INSPECTION REPORT

For the Property at:
134 ANYTIME ST.
OURTOWN, TX 77301

Prepared for: JOHN DOE
Inspection Date: Tuesday, December 12, 2023
Prepared by: Terry Rippee, TREC License 26120

PROPERTY INSPECTION REPORT FORM

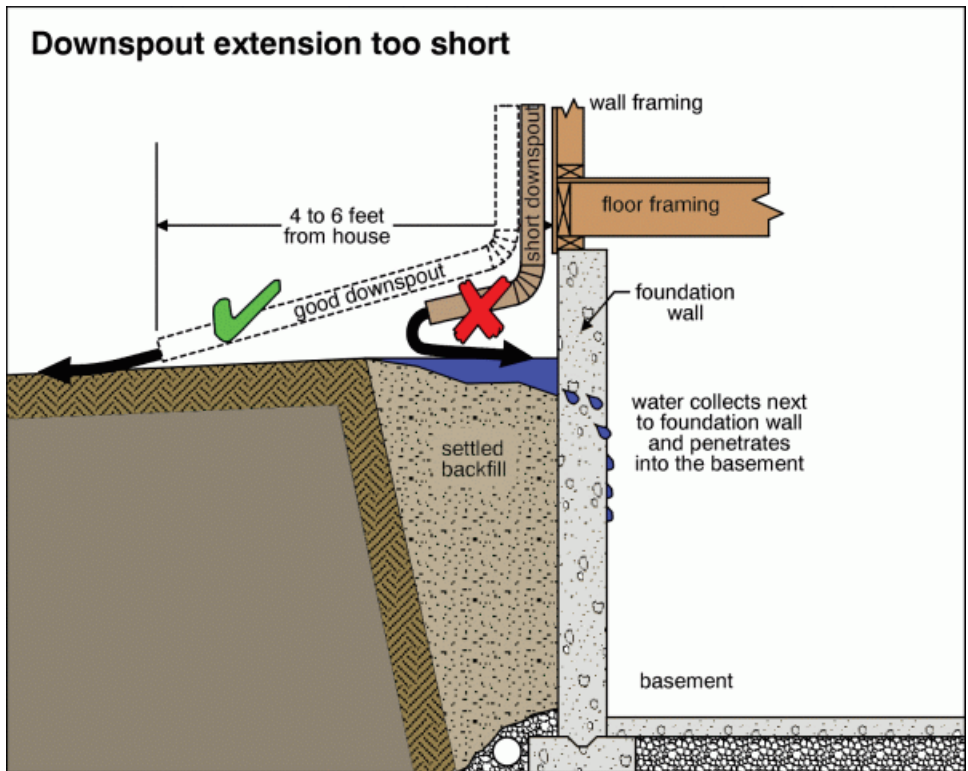
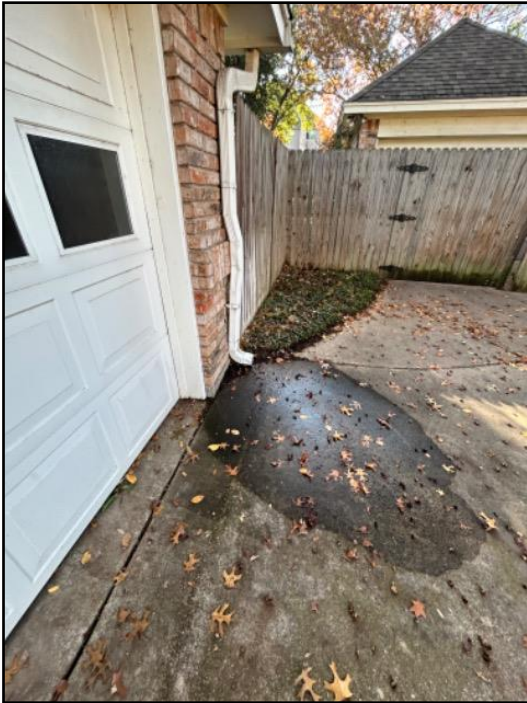
1. **Condition:** • [Should discharge 6 feet from building](#)

Implication(s): Chance of water damage to structure, finishes and contents

17. Discharge too close to building

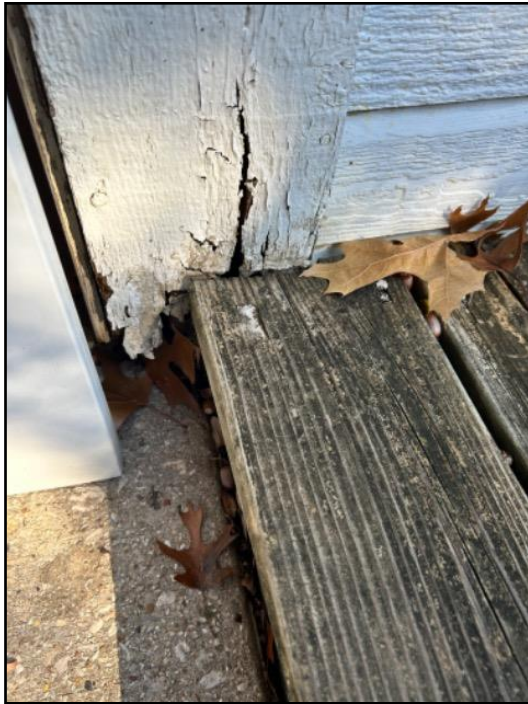
WALLS \ Wood siding
2. Condition: • [Rot](#)

Implication(s): Weakened structure | Material deterioration

18. Rot

Task: Repair Replace

Time: Immediate

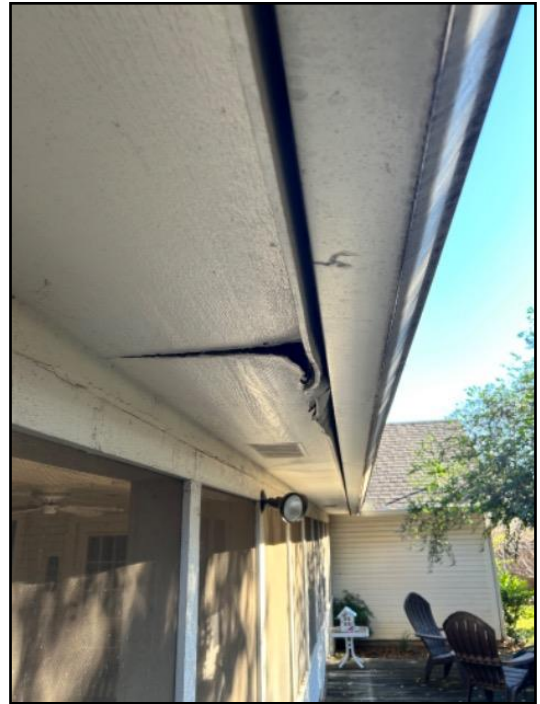
19. Rot

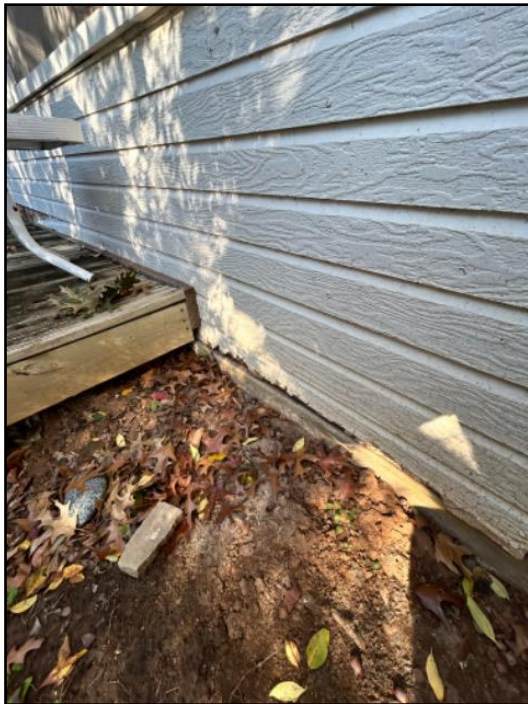
20. Rot

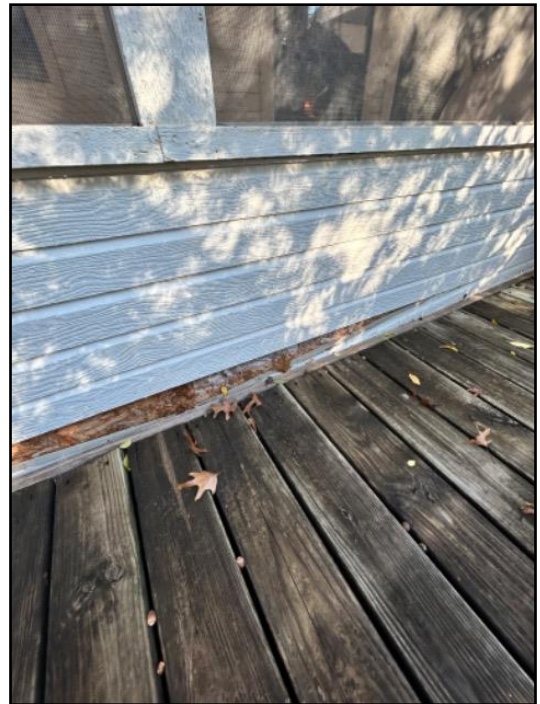
21. missing

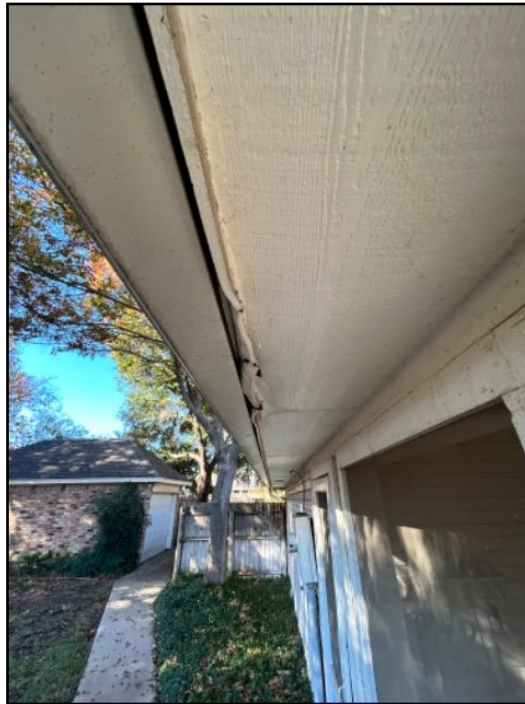
22. Rot

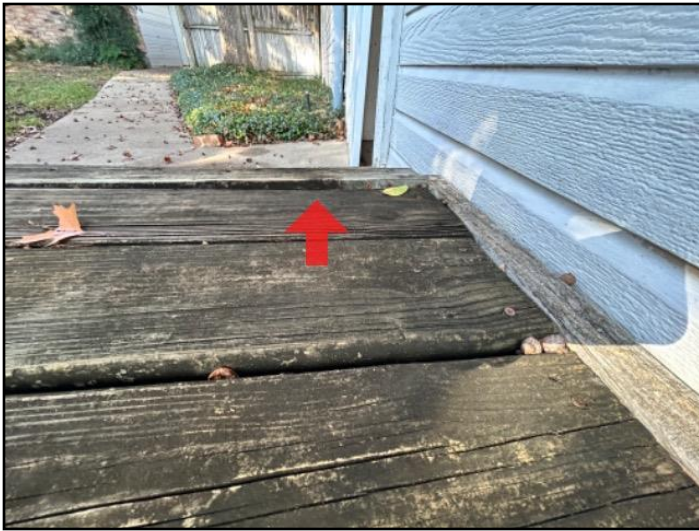
3. **Condition:** • [Damage](#)

Implication(s): Weakened structure | Chance of movement

23. Raised End Board

Task: Repair

Time: Immediate

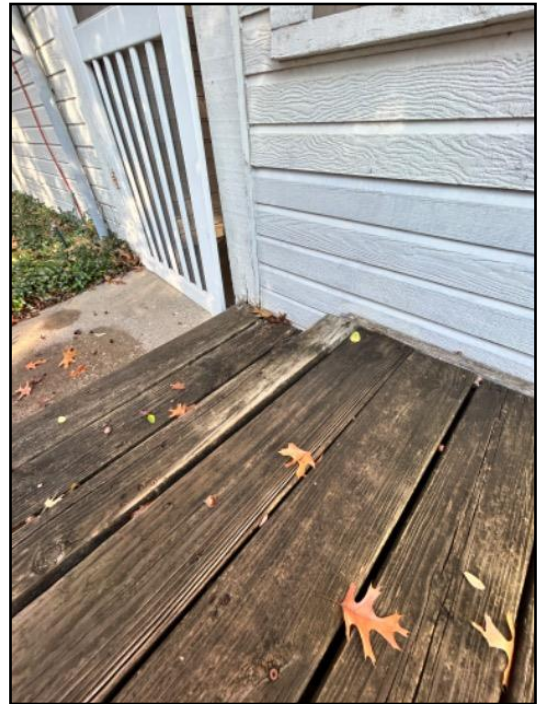
4. **Condition:** • Uneven decking is a trip hazard

24. Uneven

Task: Repair

Time: Immediate

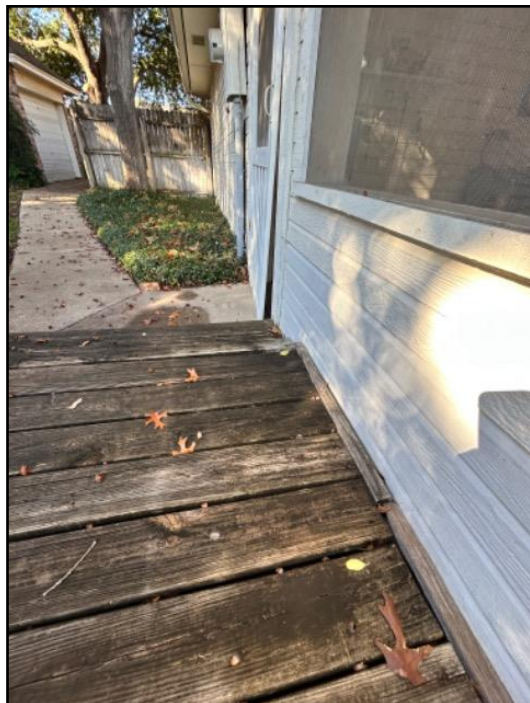
25. Uneven

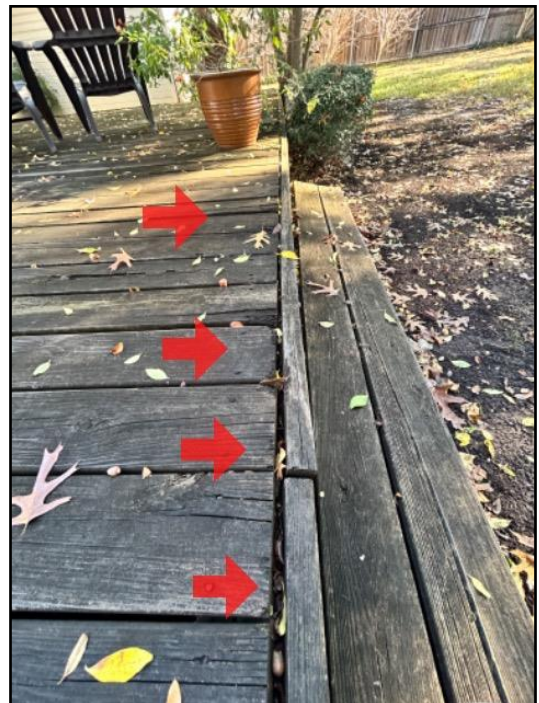
26. Uneven Boards

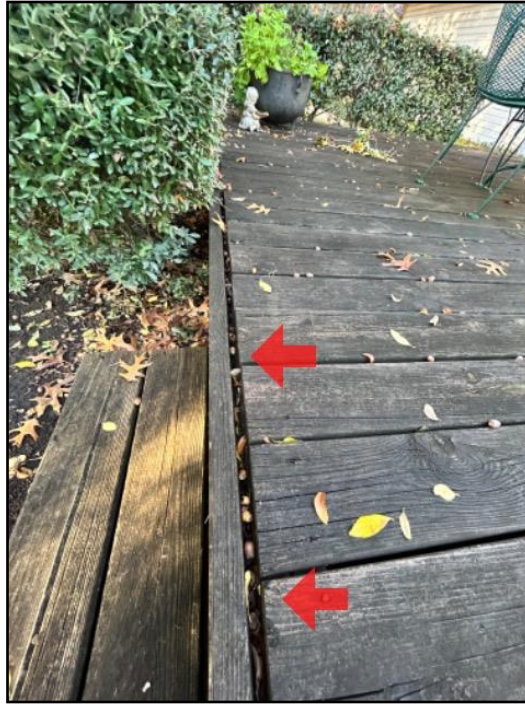
27. Uneven Boards

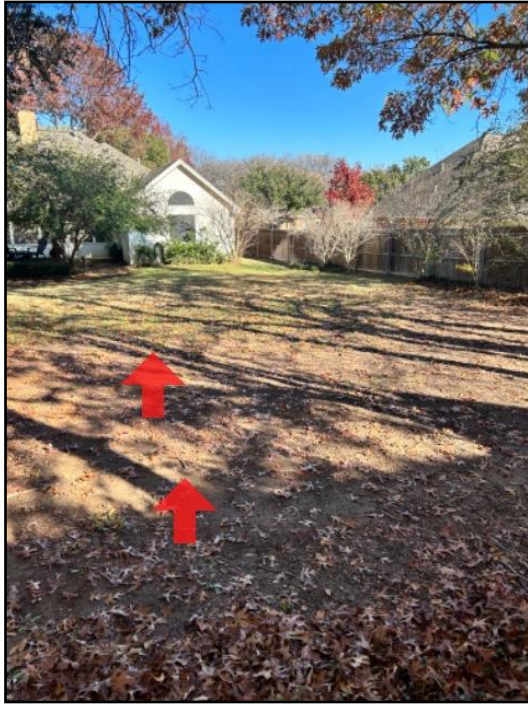
5. Condition: • [Improper slope or drainage](#)

Implication(s): Chance of water damage to structure, finishes and contents

28. *Water Drains towards the home*

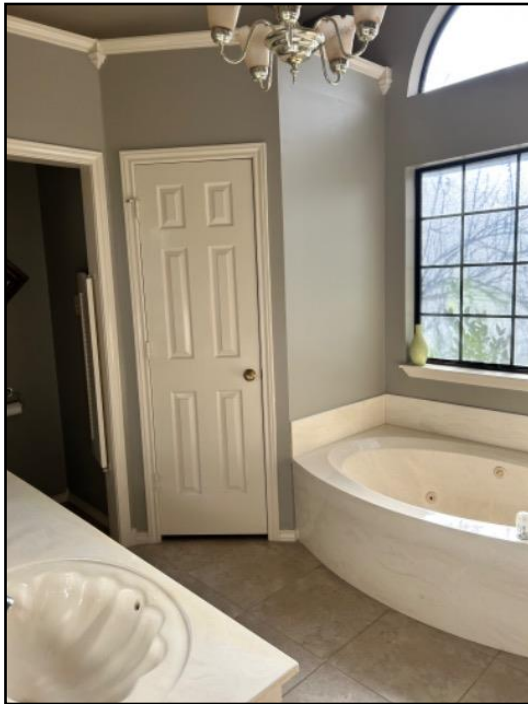
6. Condition: • Bathroom

40. Master Bathroom

Task: Replace

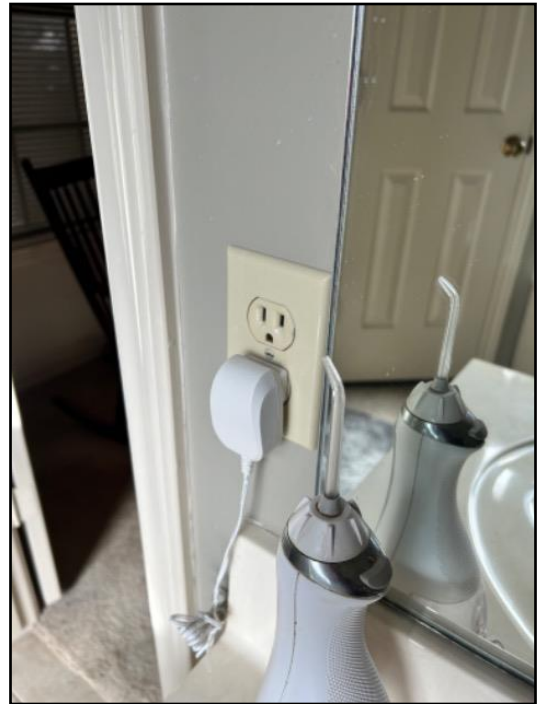
41. Should be GFI outlet

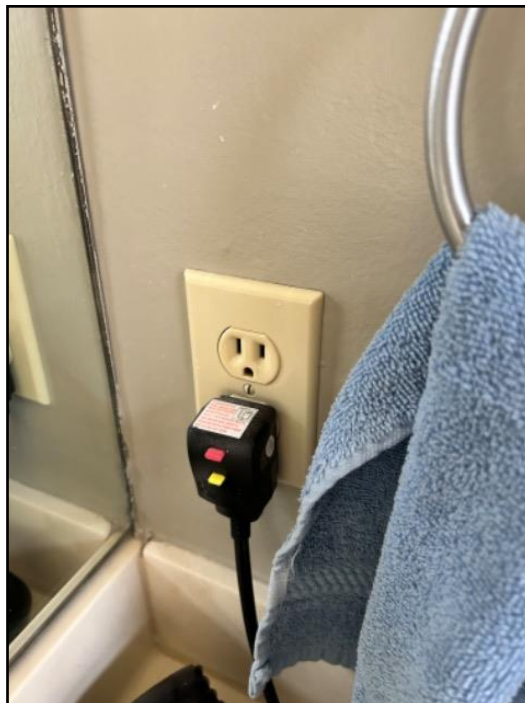
42. Should be GFI outlet

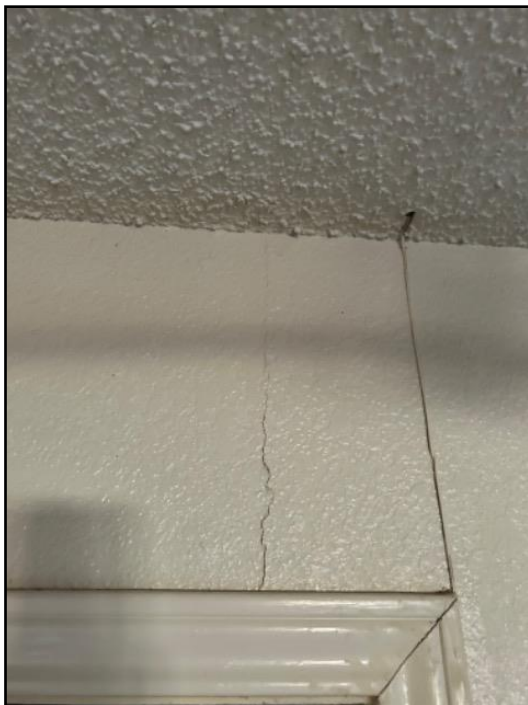
7. Condition: • [Cracked](#)

63. Cracks

Task: Repair

Time: Discretionary

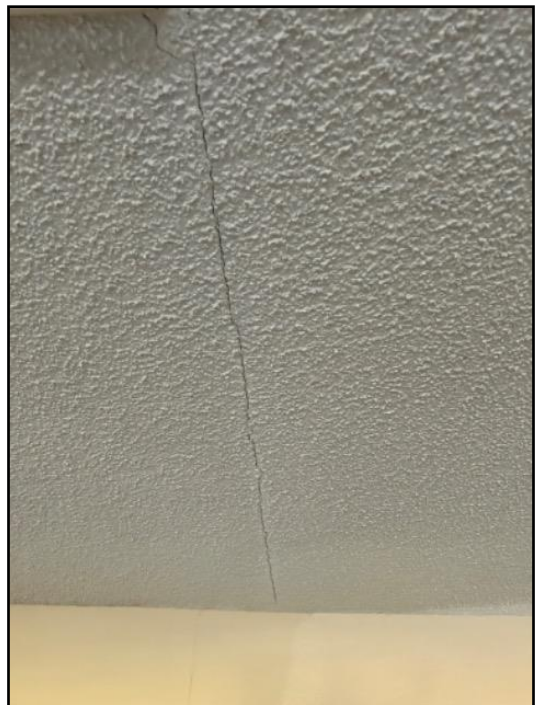
64. Cracks

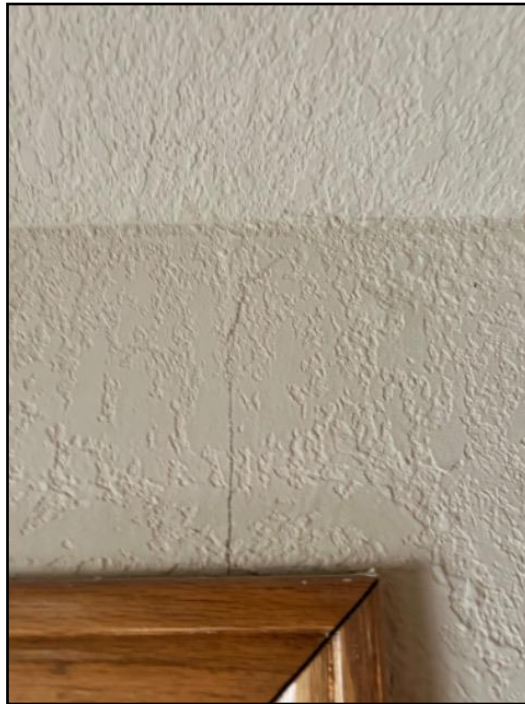
65. Cracks

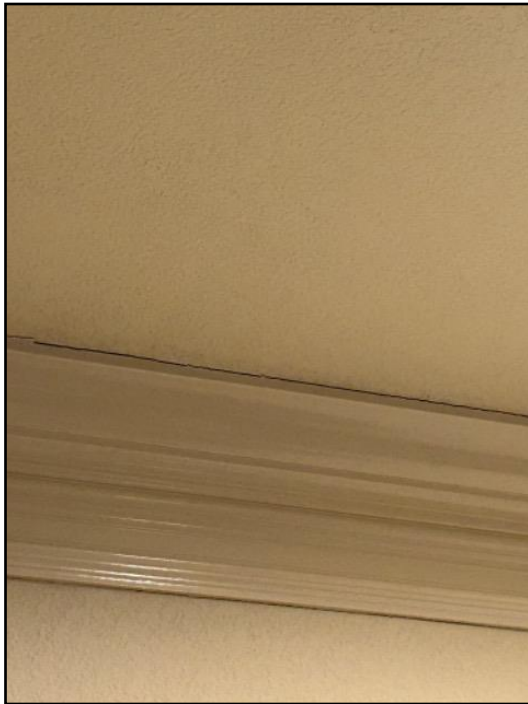
8. Condition: • [Loose](#)

Implication(s): Material deterioration

66. Separating

Task: Repair

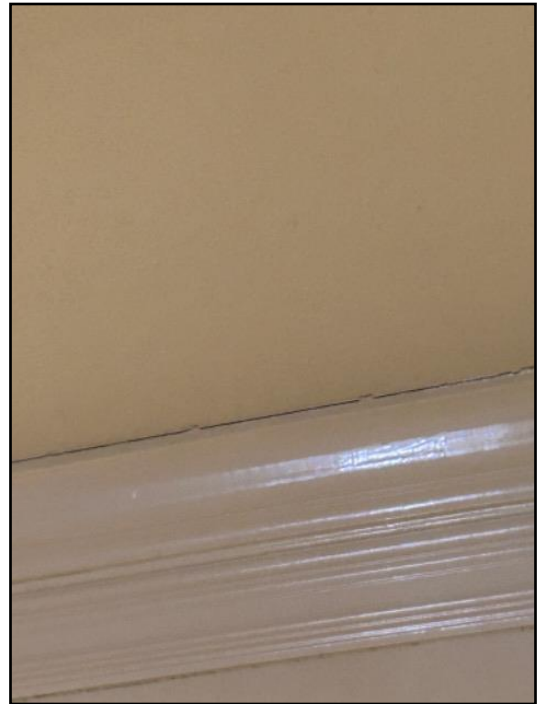
67. Separating

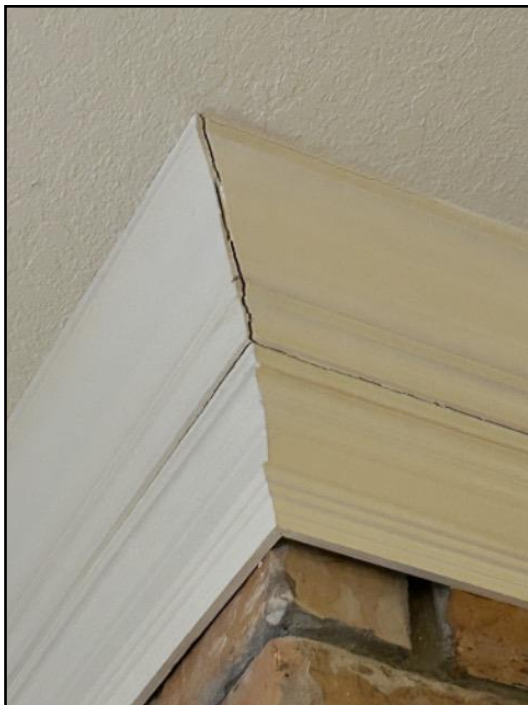
68. Separating

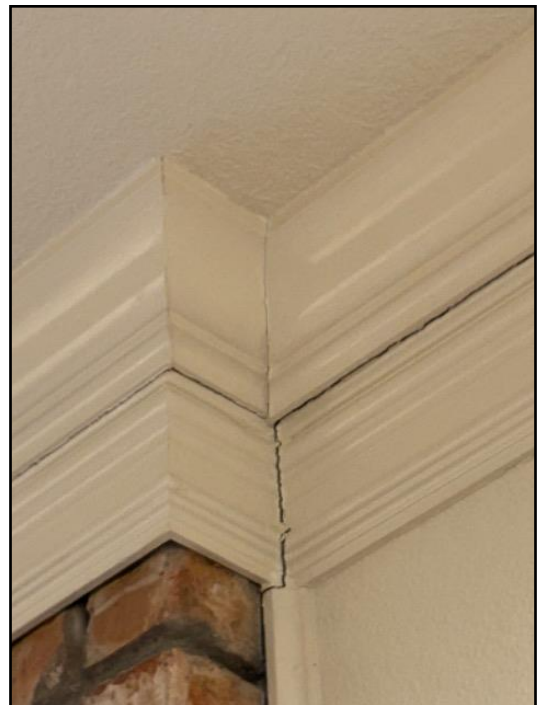
69. Separating
