INSPECTION REPORT

For the Property at:
134 ANYTIME ST.
OURTOWN, TX 77301

Prepared for: JOHN DOE
Inspection Date: Tuesday, December 12, 2023
Prepared by: Terry Rippee, TREC License 26120

PROPERTY INSPECTION REPORT FORM

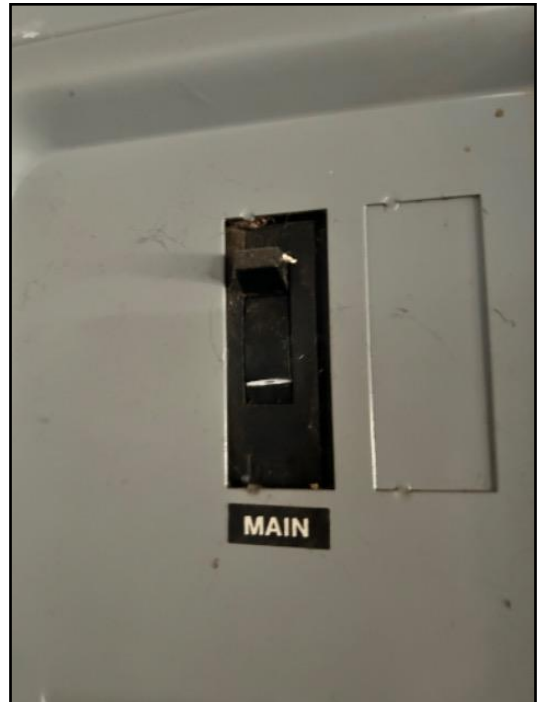
38. Main Shut Off
