INSPECTION REPORT

For the Property at:
134 ANYTIME ST.
OURTOWN, TX 77301

Prepared for: JOHN DOE
Inspection Date: Tuesday, December 12, 2023
Prepared by: Terry Rippee, TREC License 26120

PROPERTY INSPECTION REPORT FORM

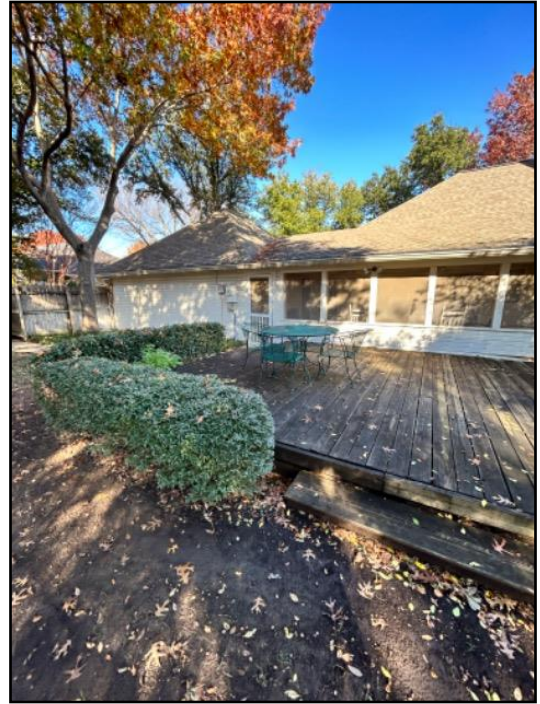
29.

28. *Water Drains towards the home*

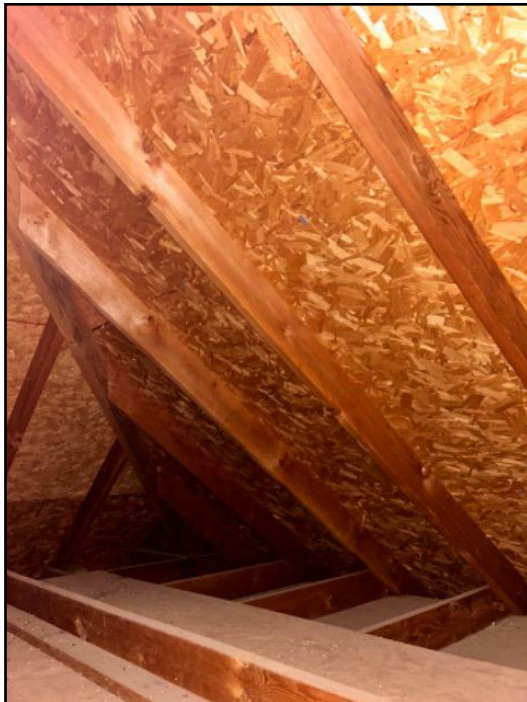
30. The attic

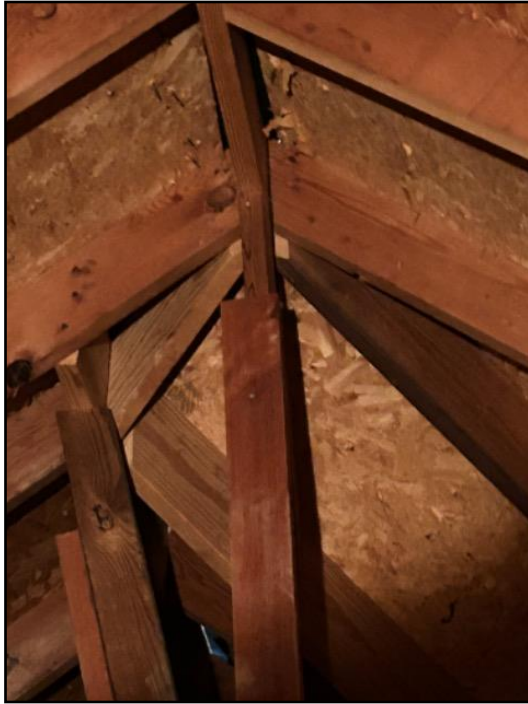
32. Rafters/ceiling joists

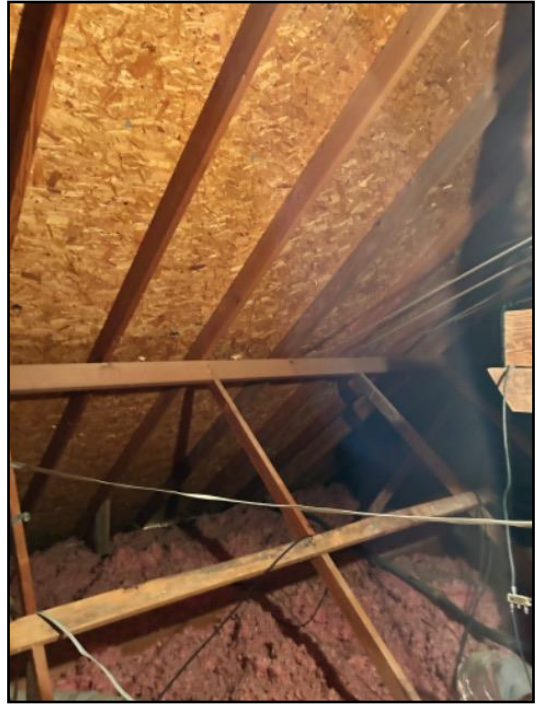
33. Rafters/ceiling joists

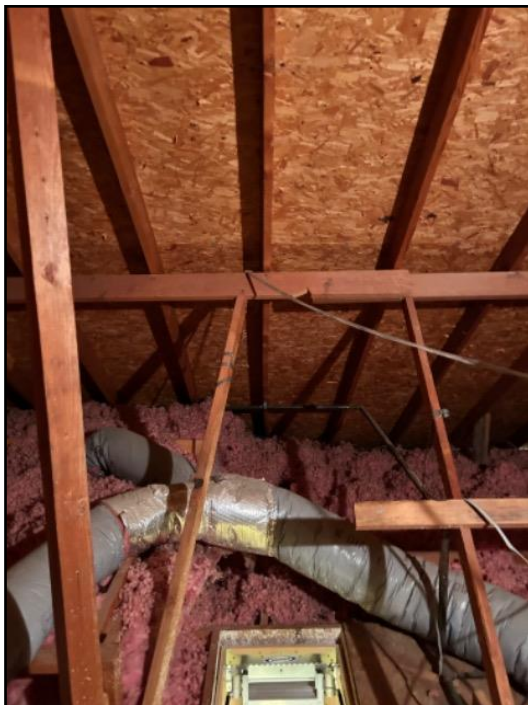
34. Rafters/ceiling joists

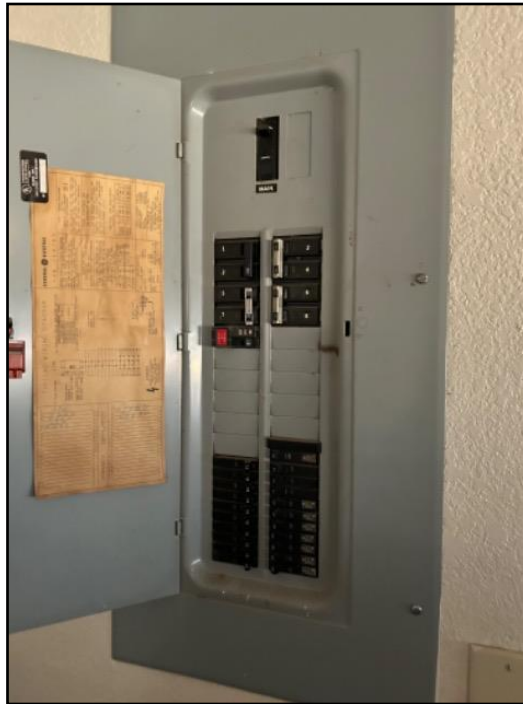
39. Breakers - garage

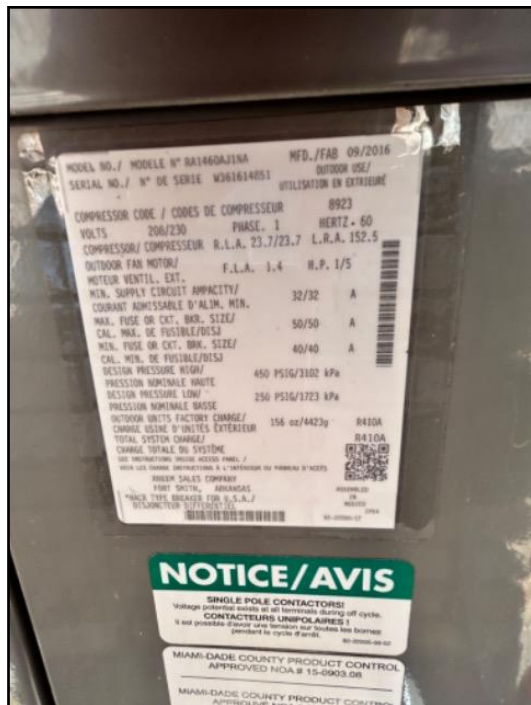
54. 7 Years

- Type of Systems: • Central air
- Air conditioning type: • Central
- Cooling capacity: • Not determined
- Compressor approximate age:
 - 7 years
